Heartland Science

Historic Barns

The Barn, a Symbol of Ohio

By Allen G. Noble and Rudy R. Christian

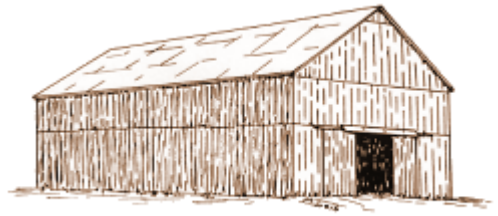
In southeastern or Appalachian Ohio, the initial settlement group was the Scots-Irish. Although they were relatively small in numbers and their settlements widely scattered, they did introduce both Single and Double Crib barns. A thin veneer of these still remains in the region. These barns were formed of square or rectangular cribs or pens made of rough hewn logs laid horizontally and held together by notched corners. Shed or gable roofs were formed of riven boards. Sixteen feet by sixteen feet were typical plan dimensions for the largest ones. However, because little level land existed in this region and all of it needed to be hand cleared, Crib barns of smaller dimensions served the earliest settlers well. The initial cribs were multi-functional, sheltering livestock, housing hay, storing equipment or holding ears of corn.

In contrast to log houses, these barns were only roughly chinked, or in some instances, not chinked at all. Not only was much valuable labor saved, if hay was to be stored good ventilation was critical to reduce the danger of spontaneous combustion. As farms gradually expanded and more barn space was necessary small specialized buildings were attached, or a second crib, pen, or shed was added, or perhaps a Double Crib structure with a roof runaway or aisle between was built from scratch as a replacement.

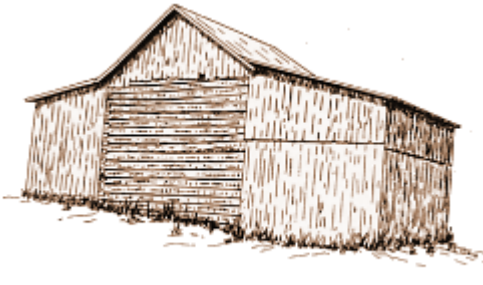
Double pen barns have been classified into at least four sub-types depending upon size and plan of the cribs and how access to them was gained, from a center aisle or directly from outside (Noble 1984, 2:2).

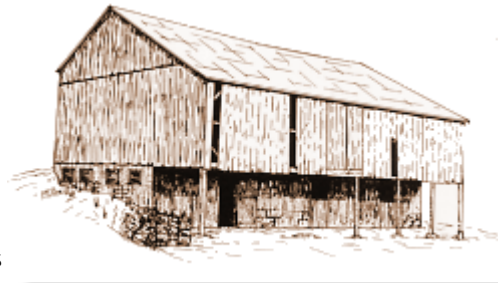
Later on, as settlement matured, and especially after saw mills became common, transverse frame barns replaced the original double pen log ones. Doors of these later barns are always on the gable end of the structure. The ground plan of the barn may provide for one, two or three aisles, with a corresponding number of doors on each gable. The Transverse Frame barn normally is longer than wide.

Dimensions of 24-30 feet by 36-45 feet are not unusual. The ground level is given over to sheltering livestock, grain storage, and equipment housing and the loft provides space for hay. Multi-function barns are the norm in most of Ohio's agriculture areas.

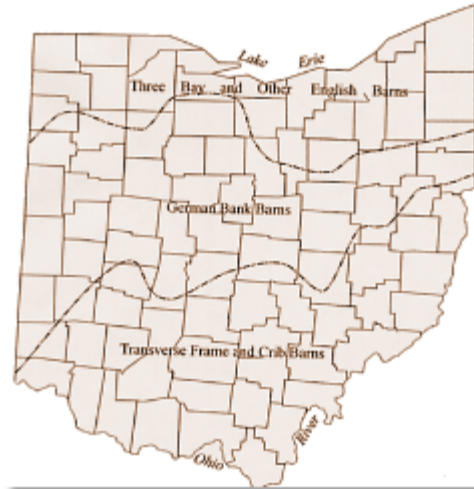
These barns had two full stories plus a half story loft and were partly excavated into the bank of a hill slope. The lowest level entered

from the downslope side was primarily for housing animals and because it was partly below ground, it was warm in winter and cool in summer. The upper floor was cantilevered on one, two or three sides over the basement story. The downslope cantilever was the most distinctive characteristic of the structure. Referred to as the forebay or vorschuss, the overhang often contained grain bins which could be emptied directly into the feeding lot below. Access to the upper floor was gained directly from upslope on the opposite side of the barn, allowing wagons to be driven into the structure for unloading. Hay mows were located on either side of the central driveway which also functioned as a thrashing platform. In order to create sufficient draft for winnowing, the barn had two large threshing doors which opened out over the downslope feeding lot. Looked at from outside, these doors were high and suspended in air. No one ever came in or out of these doors.

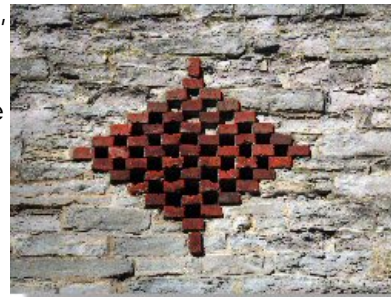
One of the most delightful features of many German barns, and a feature picked by many other farmers, is cutting out of small decorative openings high up on the gable wall. Often called owl holes, they also offer nesting openings for barn swallows. These decorative openings, which have diamond cross, heart, half moon, star, and triangle shapes, are a vestige of German barn design imported to Ohio.

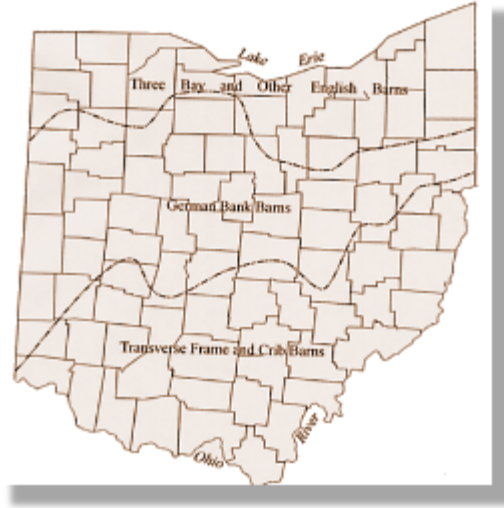
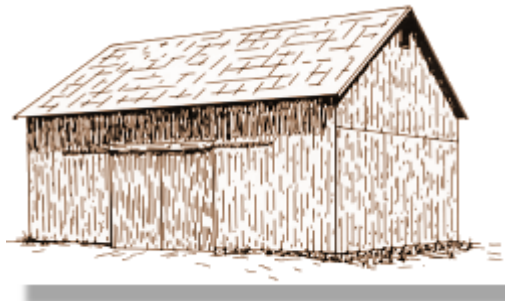
The northernmost third of Ohio is the location of barns derived from New England/New York settlers, who brought earlier English building traditions into the state. The earliest of these ethnic barns was the Three Bay Threshing Barn, also sometimes called the New England Barn, the Connecticut Barn, the Yankee Barn, or the English Barn. It has a floor plan ratio of about 3:2, although additional bays may be added to the gables in later versions. Side bays function as a storage place, grain bins, stabling areas and sometimes as hay mows. The central section was the threshing area originally. Wagon doors gave access on the front side, and a second set on the back side provided the winnowing draft, as well as an easy exit for the wagon. Hay was normally stored under the gable roof in the loft.

Many Three Bay Threshing barns boast of decorated doors consisting basically of a painted "rounded arch entirely within the space of the door." "The design is usually duplicated on both sections of the main door to form the arch, and is replicated on smaller doors (Noble 1993, 26). Northwestern Ohio, with extensions into both Indiana and Michigan, accounts for the greatest number of barns with

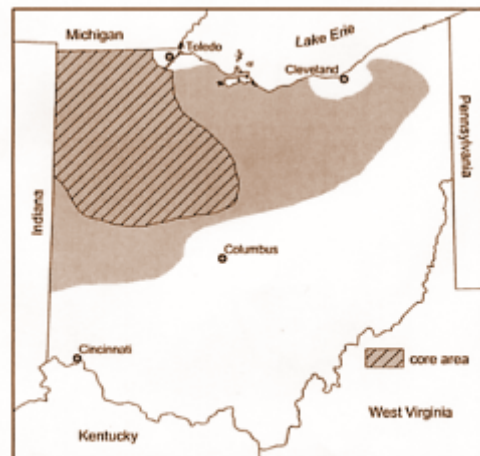
Ohio areas of decorated door barns. Core areas contain over 25% decorated door barns to total barns. Based upon Beck and Webb as modified by field traverses.

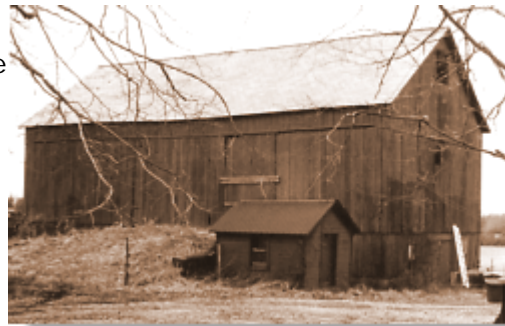
Those farmers who moved toward dairying throughout northern Ohio needed a larger structure. This need was met by the development of the Raised or Basement barn, a building quite like the German barn except for its lack of cantilevering and forebay. The Raised or Basement barn is essentially an English barn raised up, with a basement at ground level inserted beneath. Originally thought to have originated in upstate New York, or perhaps an idea borrowed after contact with Pennsylvania Germans, subsequent research has revealed probable antecedents in the Pennine region of the U.K.

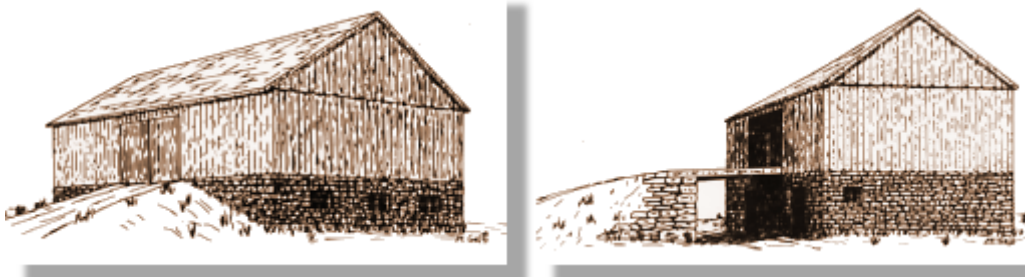
Entry to the basement is usually through doors on the gable ends of the structure, another difference from the downslope-side entrance of the German Bank barn. Entry to the upper floor of the Raised barn is by means of a ramp or barn bridge. This, of course, meant that the Raised barn could be readily built on level lands, which predominate in the western half of Ohio.

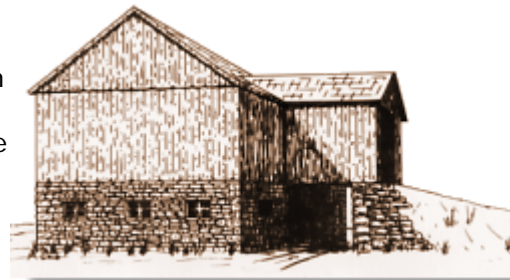
A closely associated feature both on some Three Bay Threshing barns and some Raised or Basement barns, which may indicate an English origin, is the covered porch entry. This is by no means found on all such barns, but at the same time, it rarely occurs on other types. Northeastern Ohio possesses the greatest concentration of entry porches (Noble 1993, 24).

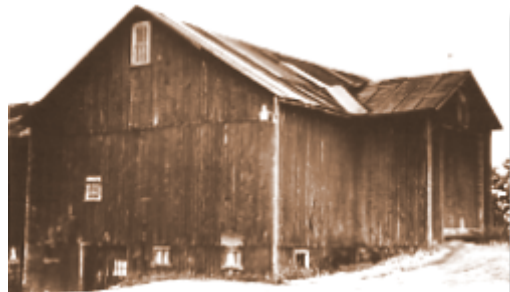
English derived settlers did contribute an English Banked barn which has been given the designation of Side-Hill barn (Fink 1987, 137-150). In almost every particular the Side-Hill barn resembles the German Bank barn. It is two and a half stories high, and partially excavated into a hill slope so that both floors are entered directly, the lower floor from downslope and the upper from upslope. The barn has inaccessible-from-the-outside threshing doors, and performs basically the same agricultural functions as the German Bank barn. It is not easily confused with the German Bank barn because it does not have an overhanging forebay. Its original antecedents are to be found in northwestern England (Brunshill 1978, 82-86; Hughes 1985, 173-174). In humid England, this barn almost always survives only in stone or brick construction. In Ohio, the Side-Hill barn has a stone foundation, but otherwise is in wooden construction.

The axis of the Side-Hill barn lies along the slope of the land. A few somewhat similar, two and a half story barns have their long sides athwart the slope and doors are on the gable ends. These barns seem to have originated near the Welsh-England border area. They have been given the designation of Welsh Gable-Entry barns (Noble and Cleek 1995, 84). In any event, they represent a small minority of banked barns in both the British Isles (Williams 1986, 167-170) and even less in Ohio.

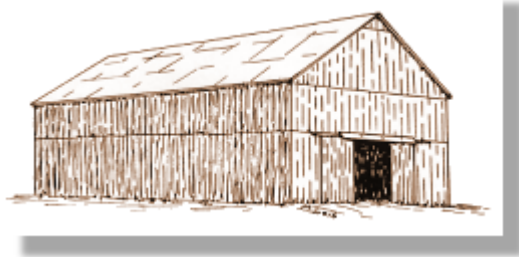
As time passed, the Ohio Saxon barn incorporated modifications which enabled it to perform differing agricultural functions better. Additional aisles were added, accessed by smaller doors on the gable. If used primarily for crop storage and processing, the structure is usually termed the Transverse Frame barn, or sometimes the Midwest Three Portal barn.

A threshing floor occupies the center and the other interior features of the Ohio Saxon barn are peripheral. The major difference from the Ohio Saxon barn is the orientation of the entryway. If used mostly for livestock, the structure is termed a Feeder barn, with a row of cow stanchions on either side of the central aisle. A connection with transverse frame barns brought into Ohio from Appalachia cannot be discounted (see Crib barns).

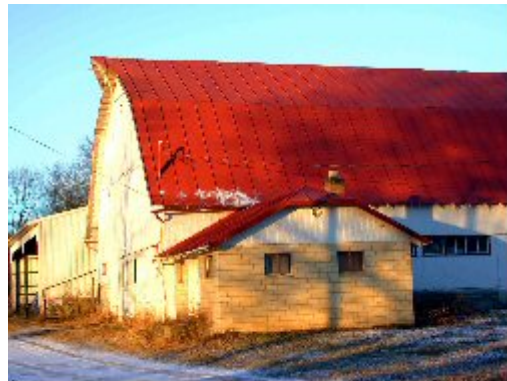
Dairying continued to expand and the form of buildings accommodated the change. The most profound modification toward the end of the 19th century was the development of the tower silo. These sentinel-like structures enabled green fodder to be stored and fed out during the winter months. Previously, cows had to be fed on dry grain and hay with the result that they dried up and could not be milked. Feeding green fodder

permitted milking all year long, satisfying the growing demands of expanding urban populations.

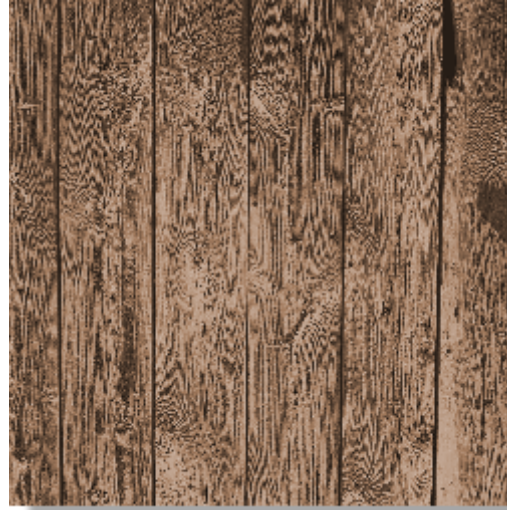
In early 19th century barns the roof sheathing was covered with wooden shakes. These "shake shingles" were split from white or red oak billets using wedges and clubs to form sections that were then carefully "riven" with a froe to a consistent size and thickness. By the early 20th Century, more durable roofing was provided using "standing seam" galvanized steel or thin slates. The steel roofing was supplied by the mills that had grown up in the big industrial cities of the Great Lakes, while the roof slates were transported by rail from the Vermont-New York, and Eastern Pennsylvania quarries. These "stone shingles" were hand split from larger quarried blocks. The use of slate in America can be traced to the colonial period, but in Ohio its popularity was dependent on improved transportation, first by canal and quickly thereafter, by rail freight. By the 1880s slate had established itself as a competitive roofing material (Stephens 1995, 246).

A heavy and durable roof material slate's thickness is the critical factor in determining weight. "A modest-sized barn having thirty squares of standard three-eighths-inch slate shingles would require, at a minimum, nine tons of roofing material (Stephens 1995, 247). Where farmers could afford the additional expense, decorated patterns produced by different colored slates, or dates, names, or initials were incorporated in the roof. The pattern of decorated slate roofs shows that most of them were erected in the northern half of the state, reflecting the greater agricultural productivity and prosperity in that area. Many beautiful slate roofs on Ohio barns are now over a century old and bear the date to prove it.

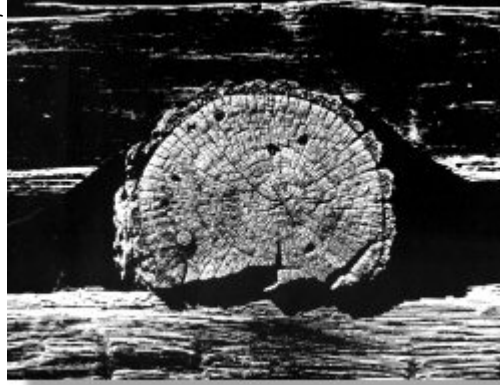
Squaring up the timber, whether by hand or with a sawmill, is of course only the first step in building a timber-framed barn. The next step the master builder took was to begin the process of "laying out" the joinery. Since timber framing is a system of building with wooden timbers held together with wooden pegs or connections (joinery), nearly every piece of wood in the frame needs to have mortices and tenons laid out and cut into it. The care and accuracy with which this work was done was not only the mark of a fine craftsman, but an important

part of insuring all the hundreds of parts of the timber frame would fit together properly on raising day. To the lay person this appears an amazing feat indeed, but generations of timber framers have refined and passed on the knowledge that makes it all a system that could be easily repeated from one barn frame to the next.

Laying out timbers has evolved as framing systems and conversion methods have changed, and learning how to read the information left behind by the timber framers who built Ohio's barns can be quite enjoyable and enlightening. The information comes in various forms that begin to make sense when one learns to think like a barn builder. This might appear to be a challenge, but the methods used by early timber framers were both logical and direct. Once you begin to understand the logic, the evidence left by the builder is not difficult to interpret.

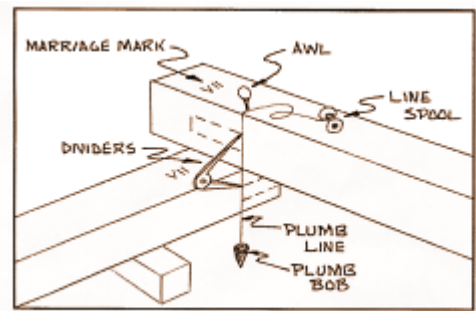
hewn timbers were often irregular in both size and shape. To overcome these defects the builder used a system that involved stacking the timbers to be cut one on the other in such a way that if you looked straight down on top of them it would look like the section of the frame he was trying to build. The frame, of course, would be stood up after it was pegged together. During the stacking process he would carefully level each timber in both directions so that he could use a "plumb" and a divider to transfer the information he needed to lay out the mortices and tenons from one timber to the next. In so doing he could "scribe" each joint to fit exactly, even if the timbers were odd sizes and shapes. This process was known as "scribe rule" layout.

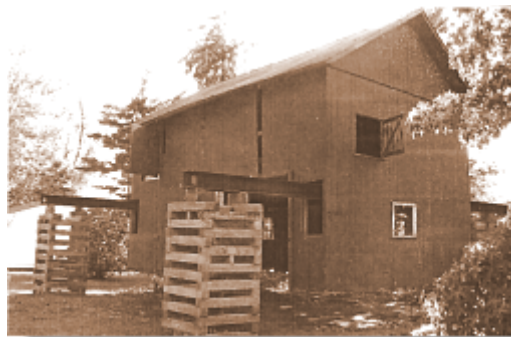
rot resistant material such as white oak. Sill replacement is accomplished by "jacking and cribbing" the barn. The jacking is usually done with steel beams which are then cribbed up with stacks of wooden beams called "blocking". In the photo to the right, a ground barn is cribbed up and ready for sill and or foundation repair.

It is common to find makeshift repairs done in barns that have suffered sill deterioration. One such "fix" is pouring concrete along the front edge of the drive bay (where the main barn doors are) or threshing floor allowing equipment access where the sill is missing. The unfortunate result is accelerated rot of the timbers that are in contact with the concrete due to moisture being trapped. The correct repair in this situation is to replace the sill with a

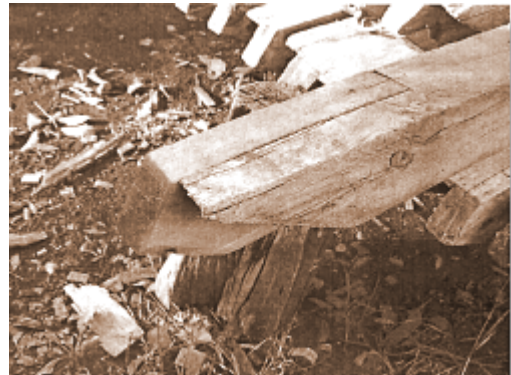
Post repair or replacement is often somewhat complex. With the exception of interior posts, the timber framer will most likely have to deal with mortice and tenon connections at the top and bottom of the post, as well as connections along its length for siding girts, tie beams and braces. It is not uncommon to find eleven or twelve mortice and tenon joints in a corner post. Dealing with these connections is a matter of analyzing the situation and designing a repair well suited to it. Post bottom repairs can be done by simply stabilizing the upper part of the post and scarfing on a new section at the bottom. If the damaged area includes wall girts or braces, free tenons may be required (see photo to right). If the entire post needs to be replaced it may be necessary to jack and crib the corner of the barn which allows the walls to be spread enough to remove the post and insert a replacement.

Another common problem, closely related to sill deterioration is rot at the bottoms of posts. This can be caused by rot in the sill traveling into the post, but it can also be caused by water getting through damaged or missing siding and trim boards. The natural tendency of water is to flow downward and it accumulates where the post meets the sill. This causes the post to rot from the bottom up. Often this is not discovered until sill replacement is undertaken and the post bottoms are exposed showing missing tenons or hollowed out posts. Often the post appears to be intact and undamaged but is found to be rotted as far as four to five feet up on the inside depending on the age of the barn and the species of the timber. In the worst cases the post is rotted from top to bottom due to water coming in through the roof or along the eave. This condition is typically visible from inside the barn without removal of siding or connecting timbers.

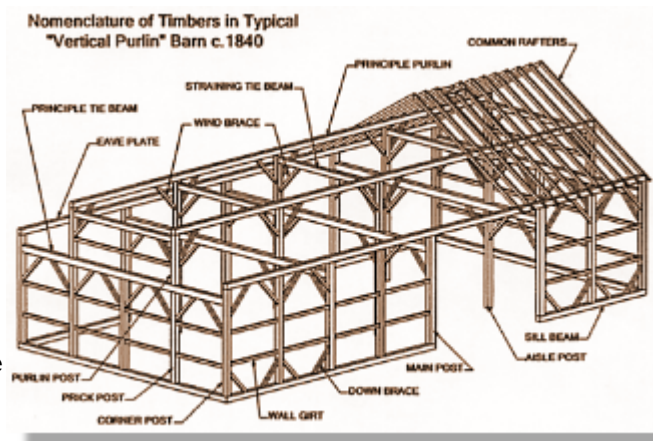
In large barns the rafters are supported by timbers called purlins. These horizontal timbers typically are placed midway between the wall plate and the ridge. In early barns it is common for these purlins to be supported by vertical posts that transfer the load of the roof into the tie beams. The figure above shows this type of frame. Provided the roof frame has not been modified, the rafters will be "birds mouthed" at the purlins which provides a stable connection. If however the "straining beams" have been removed (a common practice when hay tracks were added) the frame may require stabilization before the work proceeds.
